## CIVIL AERONAUTICS BOARD

**ACCIDENT INVESTIGATION REPORT**

TRANS WORLD AIRLINES, INC., LOCKHEED 1049A, N 6902C, AND  
UNITED AIR LINES, INC., DOUGLAS DC-7, N 6324C,  
GRAND CANYON, ARIZONA, JUNE 30, 1956

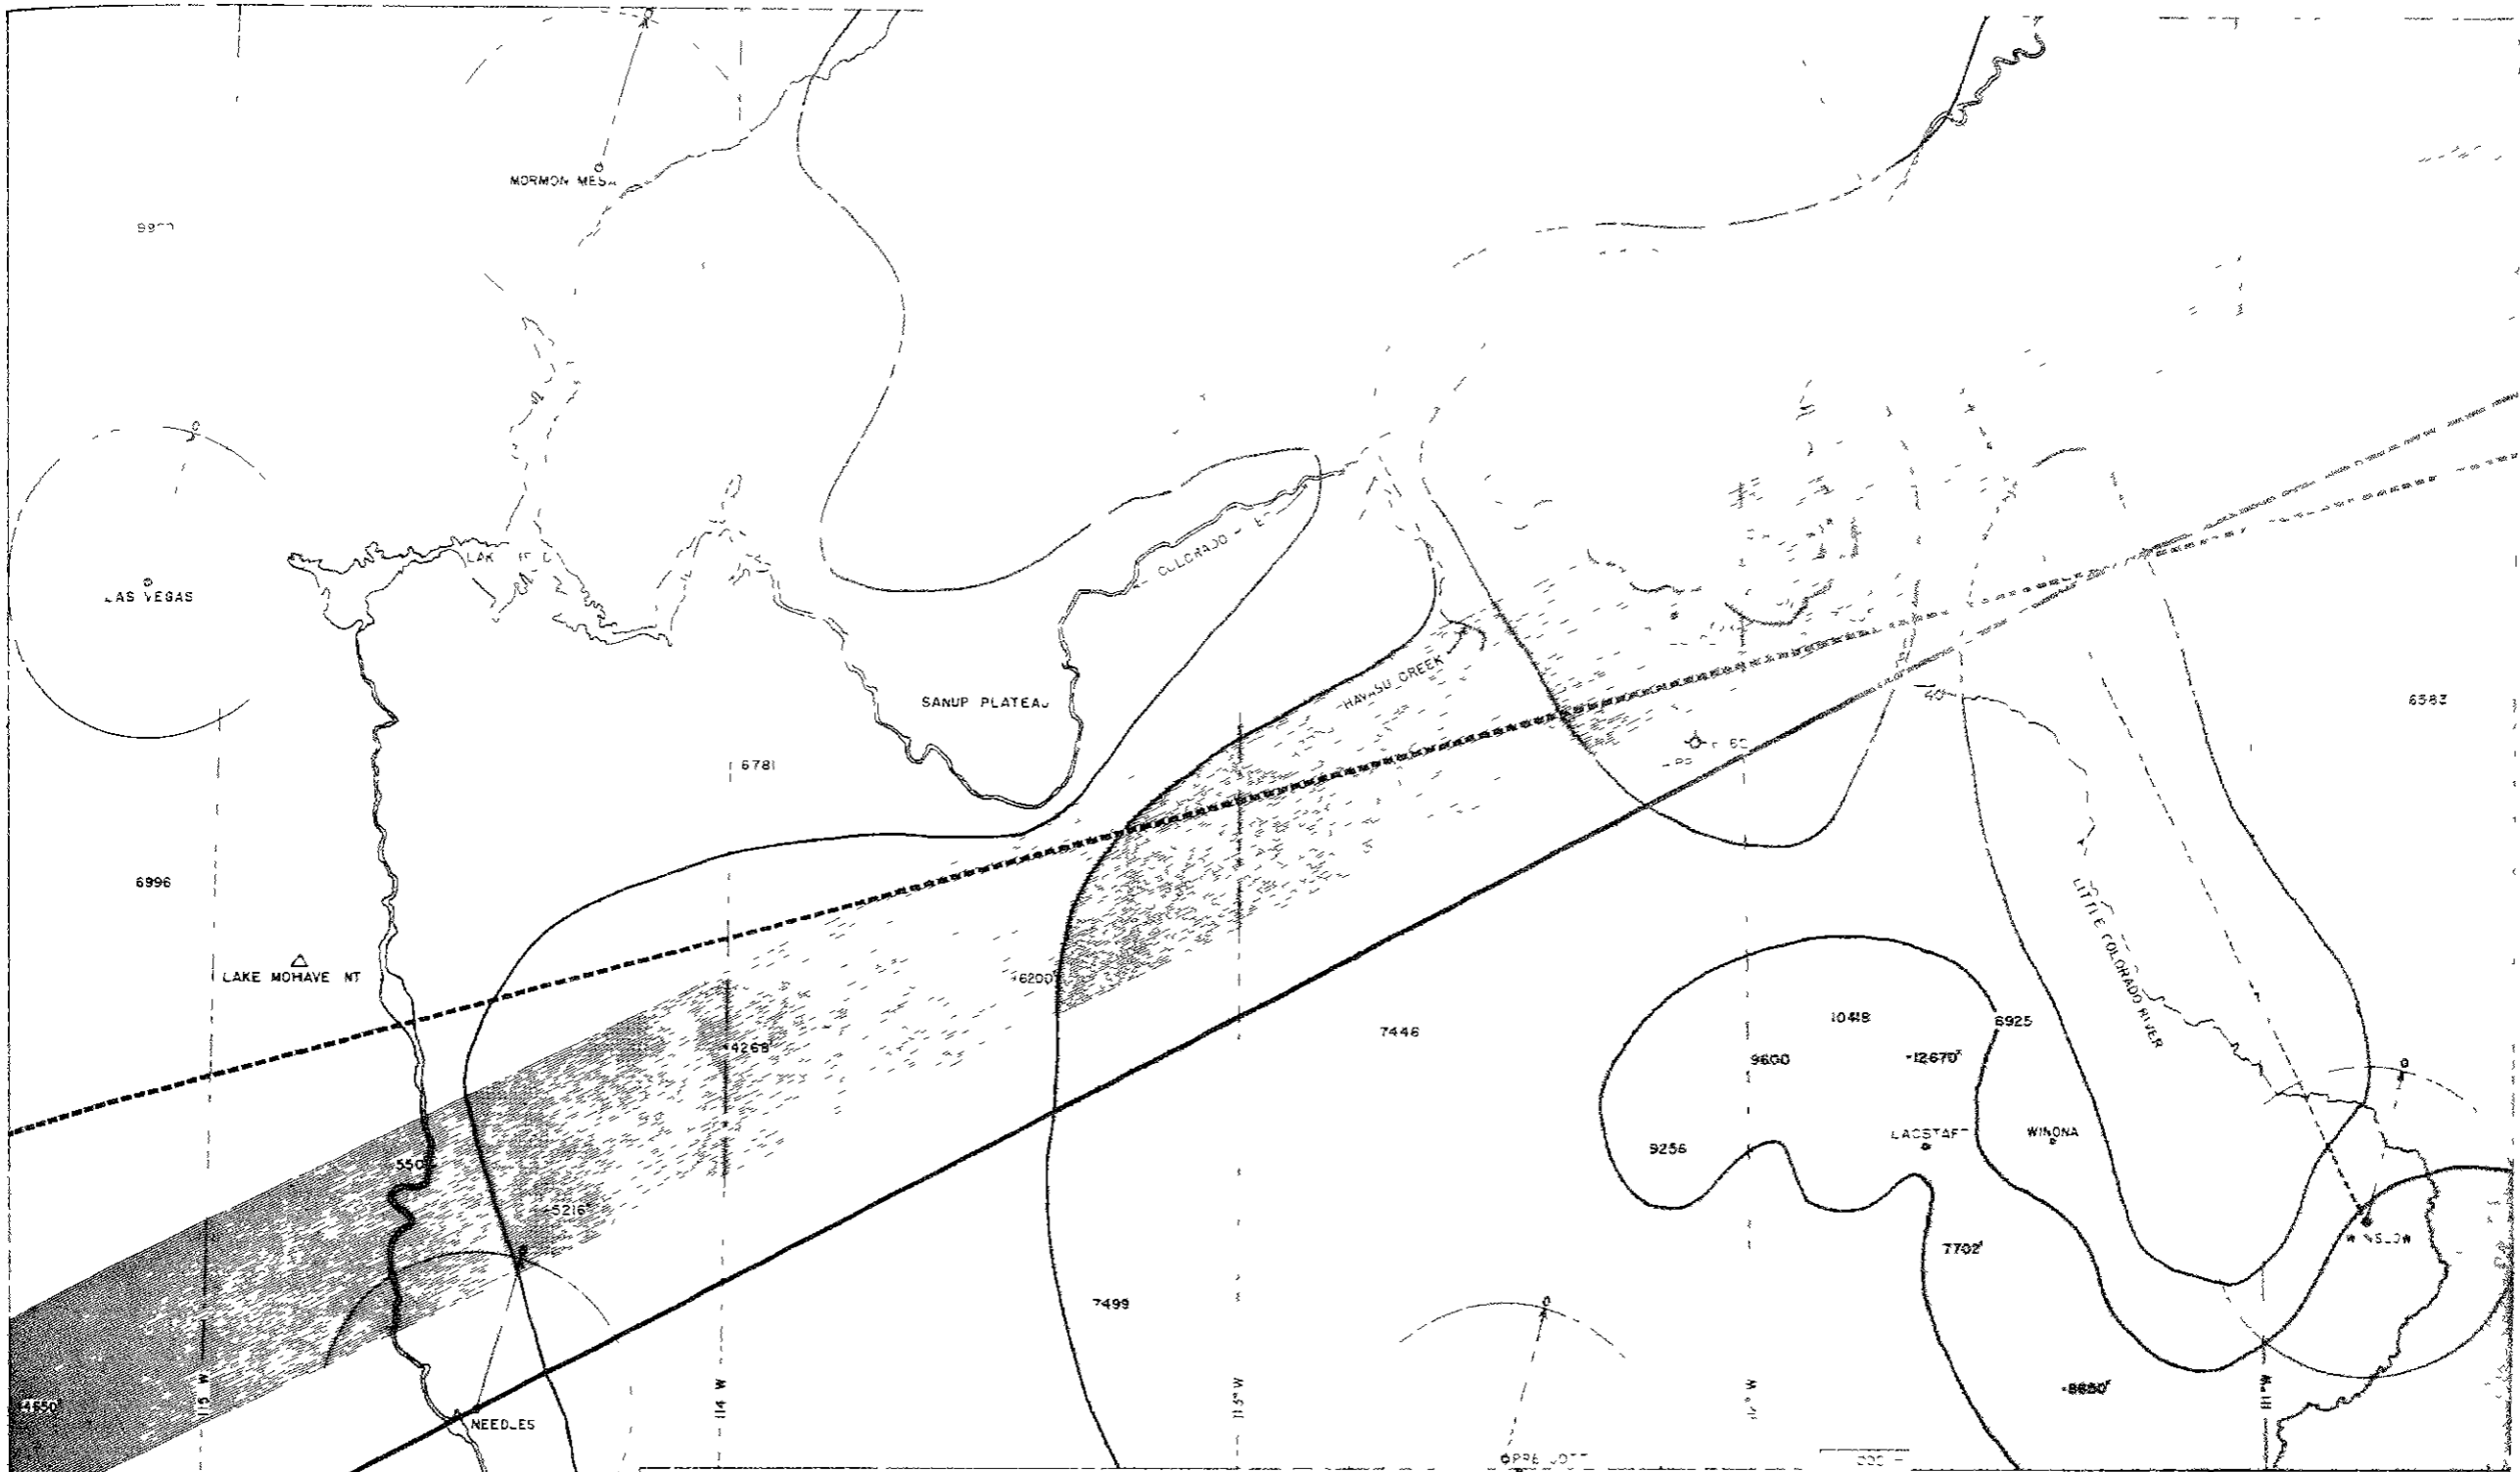
ANALYSIS OF HORIZONTAL AND VERTICAL CLOUD COVERAGE  
 TWA-UAL ACCIDENT AT GRAND CANYON, ARIZ JUNE 30, 1956  
 ATTACHMENT 2

Analysis of all the available weather information (see attachment 2 as reference), including pilot reports, indicates that the forecast conditions for the flights were reasonably accurate. It shows that the two flights departed Los Angeles and climbed through an overcast approximately 700 feet thick to clear conditions on top. The overcast was local in nature and confined to the Los Angeles coastal area. Thereafter, the flights, except for some scattered clouds, were in clear weather as they climbed eastbound over their respective tracks.

Clear weather appears to have prevailed east of Las Vegas along the Colorado River to near Havasu Creek but becoming overcast with a few breaks beginning a short distance east of Havasu Creek. Along the proposed routes of TWA 2 and UAL 718, scattered clouds commenced shortly east of the California-Arizona border. Eastward therefrom clouds increased to broken, then overcast with some breaks in the Grand Canyon area to somewhat east of the accident site. Tops of this main weather coverage were approximately 15,000 feet with several lower layers, the lowest being about 2,000 feet above the ground.

Northwest of Grand Canyon Village, or over the western portion of the main Grand Canyon, the first of several scattered buildups appears to have existed. It appears to have been isolated with others northeast of it. The build-ups were apparently formed in the lower clouds and protruded through and above them to approximately 25,000 feet. An airline captain described the westernmost buildup as large but of an indeterminable width and length. He believed it was almost over Grand Canyon Village. Pilots below the overcast saw no evidence of it there but at least two noted a rain area northwest of this position. It is entirely likely that the rain area was from the buildup noted by the captain from above. Pilots flying below the overcast also stated that they saw breaks in the overcast but that they were few and scattered. They observed that the overcast condition covered most if not all of the Grand Canyon.

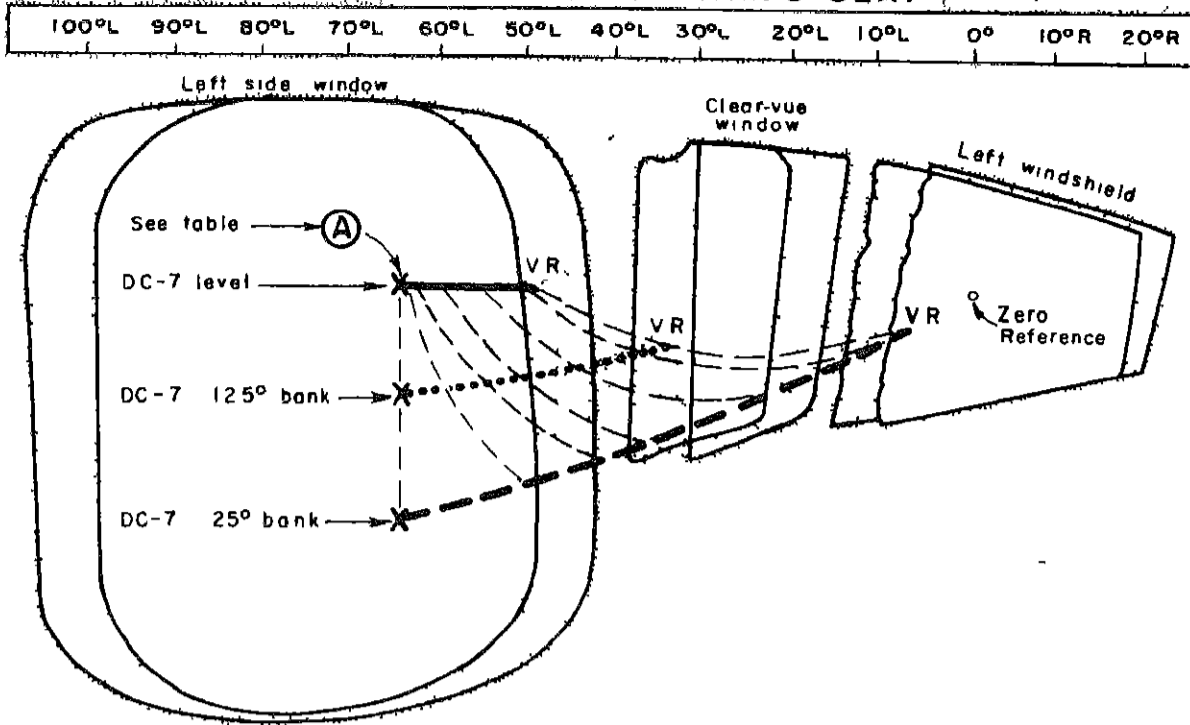
VIEW FROM CAPTAIN'S SEAT

With respect to the DC-7 first officer's position, the L-1049 was within the angular limits of the DC-7 window area during two of the limit considerations and during the early part of the other two. In the "no cloud" factor situations the L-1049 would have been near maximum visual range in two conditions, without relative motion in one, and with relative motion in another. Time opportunity without intervening clouds and with both aircraft straight and level was 120 seconds. For the other three considerations, including the intervening cloud condition, the opportunity varied from 12 seconds to 50 seconds.
